**Flood Control Project Maintenance
Levee Inspections**

2018 Channel Summary Report

San Joaquin County Flood Control and Water Conservation District

Flood Control Project Maintenance**Unit Cover Sheet****2018 Channel Inspection Results****San Joaquin County Flood Control and Water Conservation District**

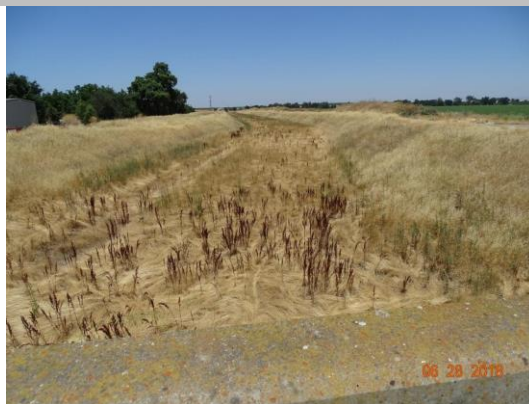
Photo 1 of 1 : CH_2018_NA0017_43_11_20180702_00014.jpg

View of the vegetation in the channel looking upstream, 2018.

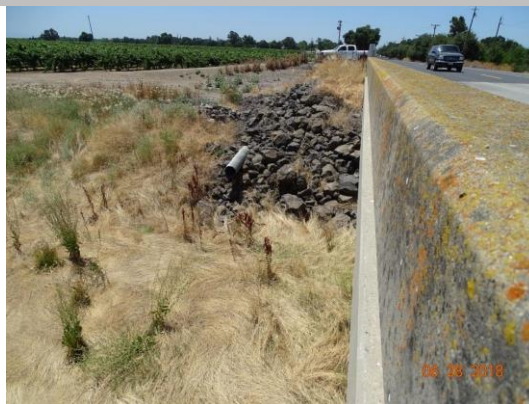
Photo 1 of 2 : CH_2018_NA0017_43_19_20180702_00020.jpg

View of the revetments on the right bank of the channel looking downstream, 2018.

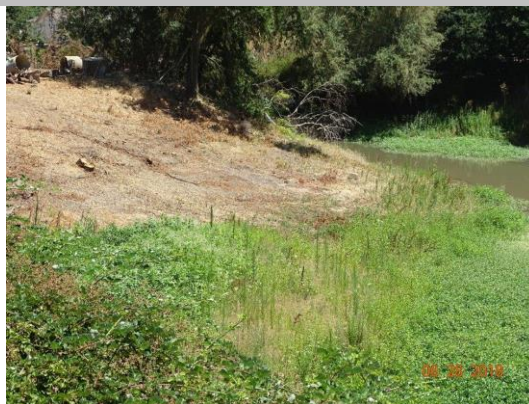
Photo 1 of 2 : CH_2018_NA0017_42_6_20180702_00077.jpg

Inspector Comments: Minimal vegetation was found, but they do not obstruct the flow of the channel.

View of the vegetation on the upstream of the channel, 2018.

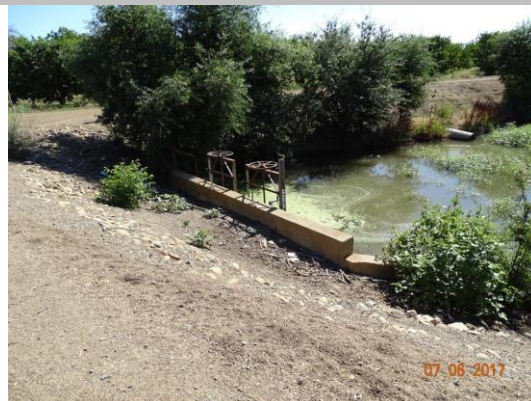
Photo 1 of 1 : CH_2018_NA0017_42_112_20180530_00048.jpg

Inspector Comments: The concrete surface appeared to be in good condition with no negligible spalling, scalling or cracking.

View of the culvert on the upstream of the channel. Summer 2017

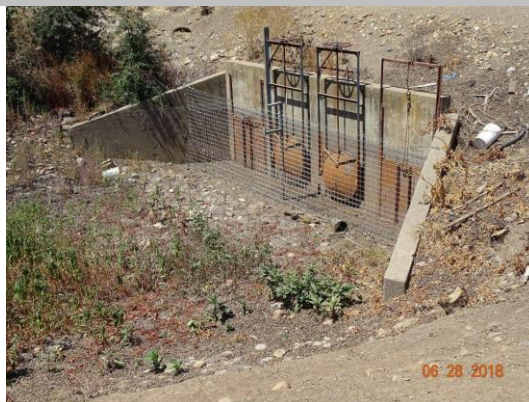
Photo 1 of 2 : CH_2018_NA0017_42_113_20180702_00075.jpg

Inspector Comments: Slide gates appeared to be in good operational condition.

View of the slide gates on the upstream of the channel, 2018.

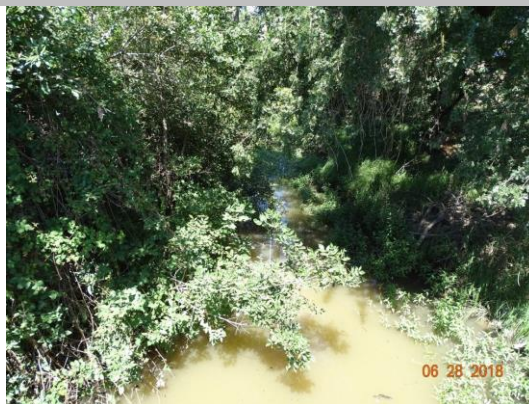
Photo 1 of 2 : CH_2018_NA0017_42_26_20180702_00071.jpg

View of vegetation looking downstream of the channel. Summer 2018

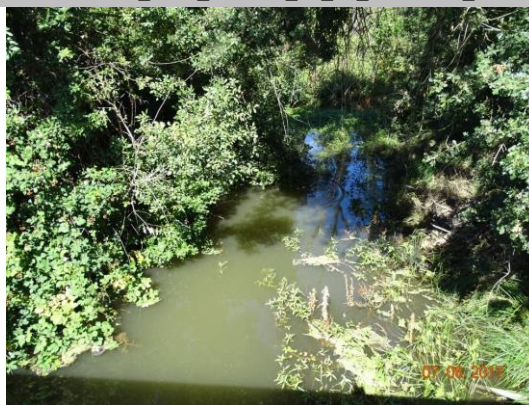
Photo 2 of 2 : CH_2018_NA0017_42_26_20180530_00008.jpg

View of heavy vegetation looking downstream of the channel. Summer 2017

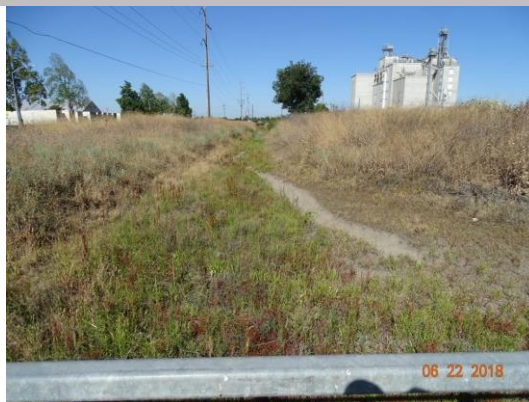
Photo 1 of 2 : CH_2018_NA0017_42_96_20180625_00056.jpg

Rating **	A	Issue No.	96	GPS Lat/Long
Issue Type +	Ma	Location *		37.908433 °
Category	Rivers, Channels & Designated Flood			-121.269214 °
Item	Vegetation & Obstructions			
DWR ID	DWR_NA0017_42_c_2012_96			
Action/Comments				
Inspector Comments: Minimal vegetation was found, but the flow is not impeded.

View of the channel looking downstream. Summer 2018

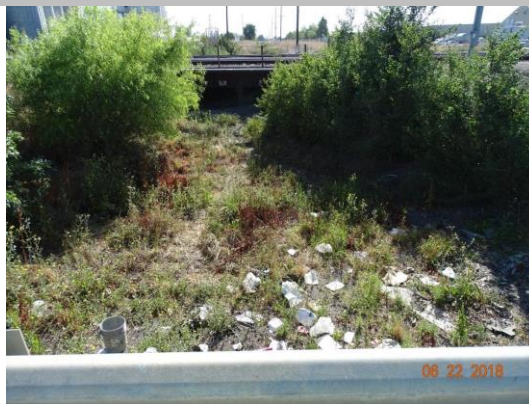
Photo 1 of 3 : CH_2018_NA0017_42_101_20180625_00051.jpg

View of the heavy vegetation on the channel looking upstream during 2018 inspection.

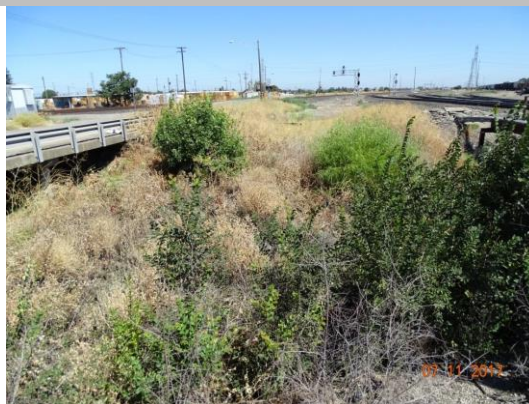
Photo 2 of 3 : CH_2018_NA0017_42_101_20180530_00042.jpg

View of the heavy vegetation on the channel looking upstream. Summer 2017

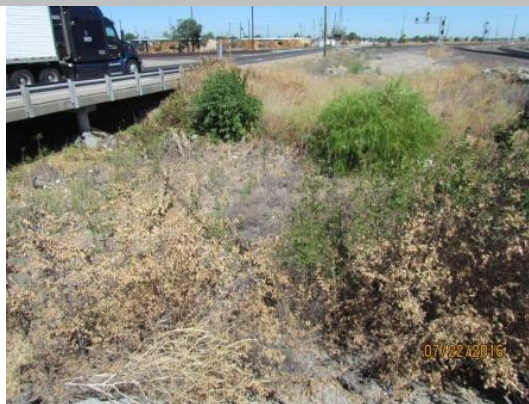
Photo 3 of 3 : CH_2018_NA0017_42_101_20180530_00043.jpg

View of the heavy vegetation on the channel looking upstream during 2016 inspection.

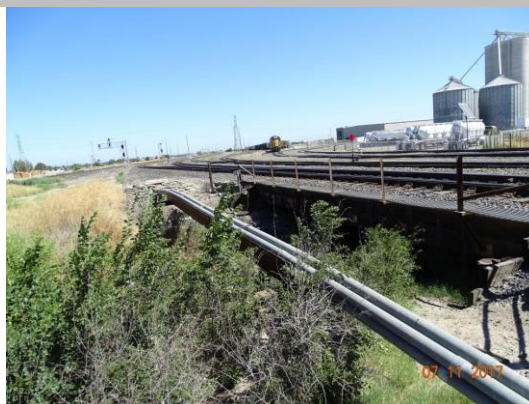
Photo 1 of 1 : CH_2018_NA0017_42_102_20180530_00044.jpg

View of non-aquatic plants in the channel looking upstream.

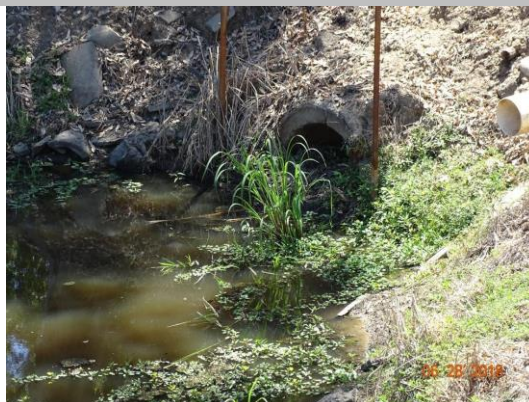
Photo 1 of 1 : CH_2018_NA0017_44_108_20180703_00087.jpg

Inspector Comments: The pipe appeared to be in good condition.

View of the pipe looking upstream of the channel. Summer 2018

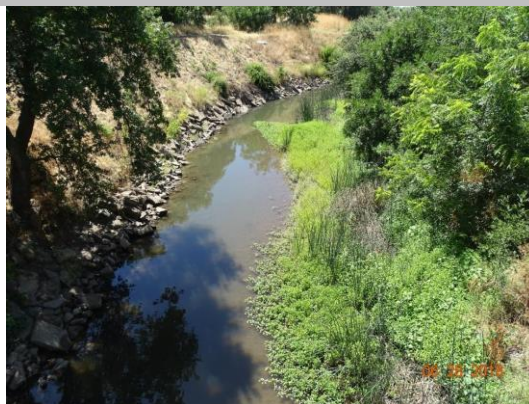
Photo 1 of 1 : CH_2018_NA0017_44_26_20180703_00094.jpg

Rating **	A	Issue No.	26	GPS Lat/Long
Issue Type +	Ma	Location *		37.925330 °
Category	Rivers, Channels & Designated Flood			-121.000120 °
Item	Vegetation & Obstructions			
DWR ID	DWR_NA0017_44_c_2012_26			
Action/Comments				
Inspector Comments: Minimal vegetation was found in the channel not likely to impede the flow.

View of the channel looking downstream during 2018 inspection.

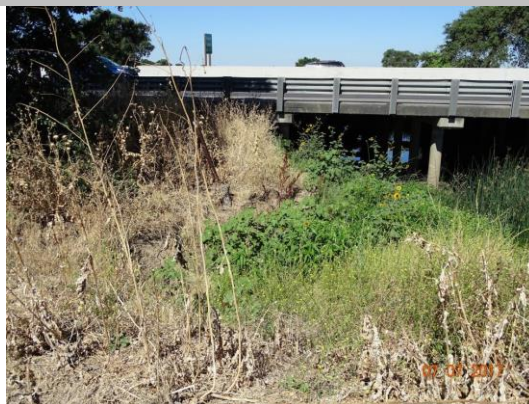
Photo 1 of 2 : CH_2018_NA0017_44_83_20180530_00043.jpg

View of the erosion on the channel bank looking upstream. Summer 2017

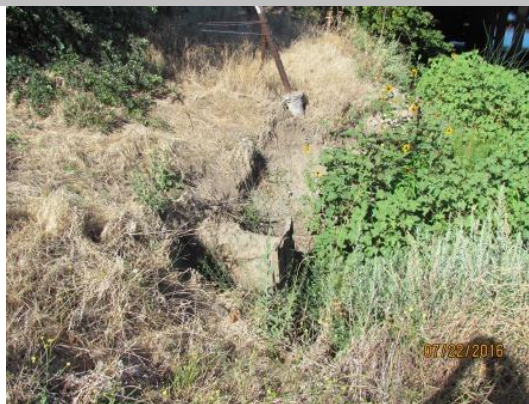
Photo 2 of 2 : CH_2018_NA0017_44_83_20180530_00044.jpg

Updated picture of the erosion on the left bank of the channel looking upstream.

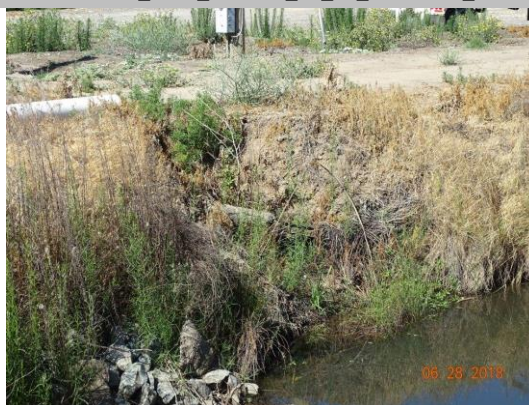
Photo 1 of 2 : CH_2018_NA0017_45_18_20180702_00037.jpg

View of bank erosion on the downstream of the channel. Summer 2018

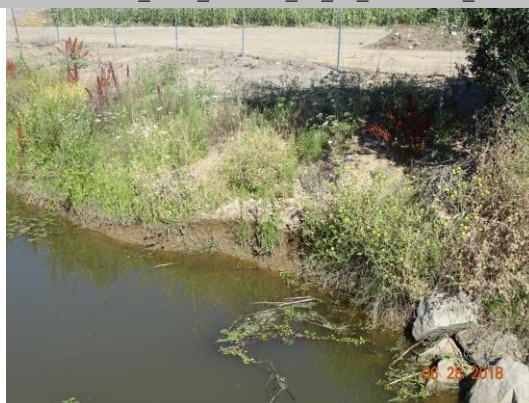
Photo 1 of 2 : CH_2018_NA0017_45_28_20180702_00033.jpg

View of the erosion on the right bank of the channel. Summer 2018

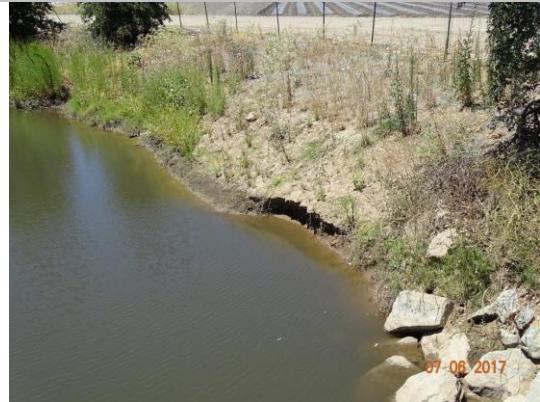
Photo 2 of 2 : CH_2018_NA0017_45_28_20180530_00014.jpg

View of the erosion on the right bank of the channel. Summer 2017
